# Roof Condition Report (Level 2)

13 March 2025

4 Sample Road, SE8 \*\*\*

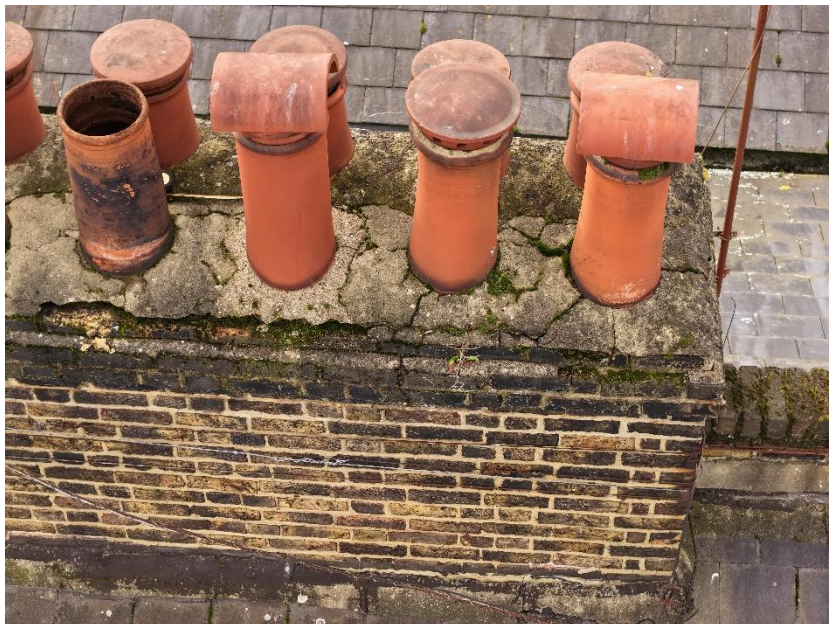
Cracked flaunching (48).

Replace cracked chimney flaunching.

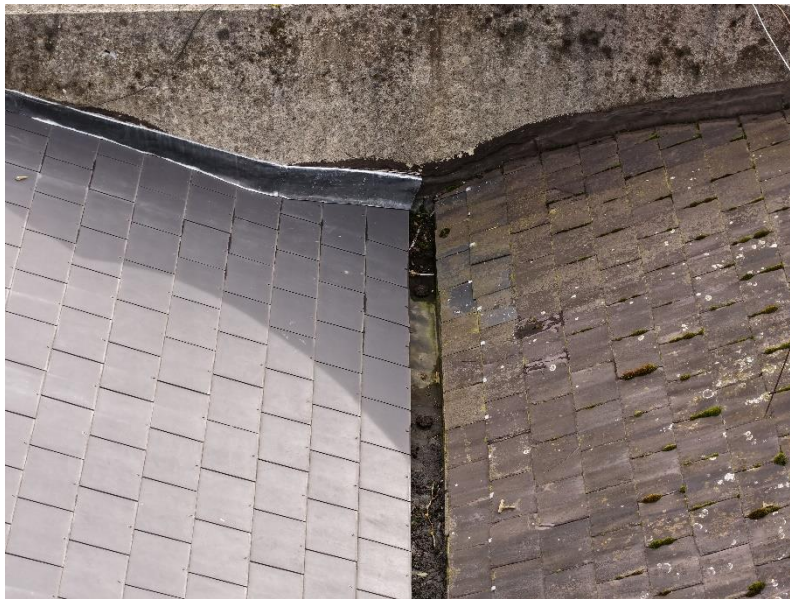
Loose lead to new roof (69).

1. The new lead flashing at the bottom is coming loose and requires re-fixing and the application of lead sealant.
2. The brick-on-edge atop the parapet wall needs cleaning and some repointing.

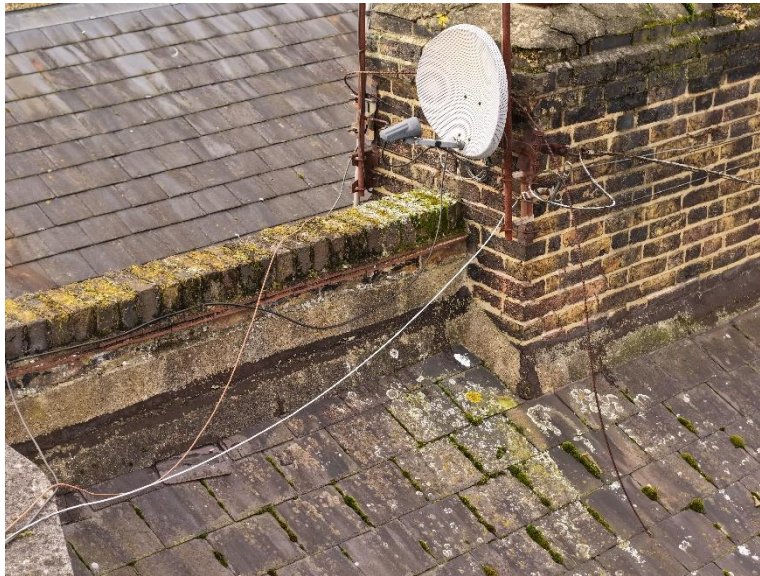
Slates slipped or missing (54).

Replace broken or missing slates.

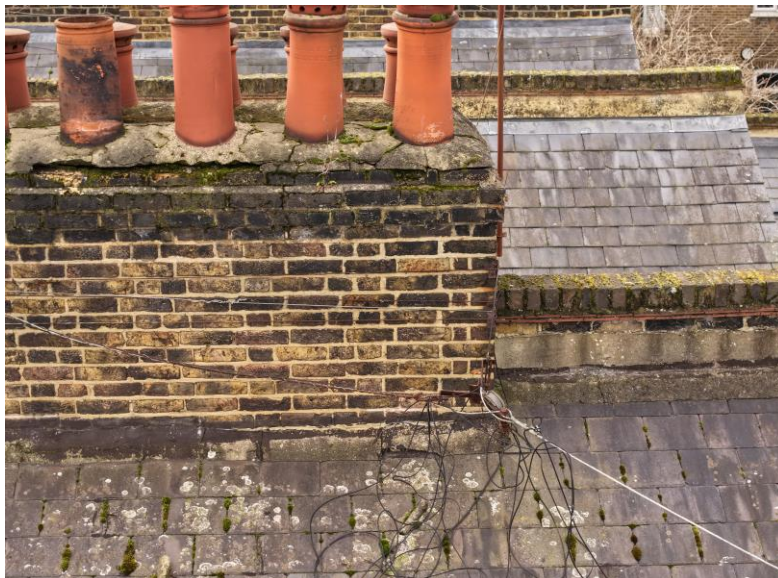
Loose pointing to chimney (58).

Re point chimney and parapet walls.

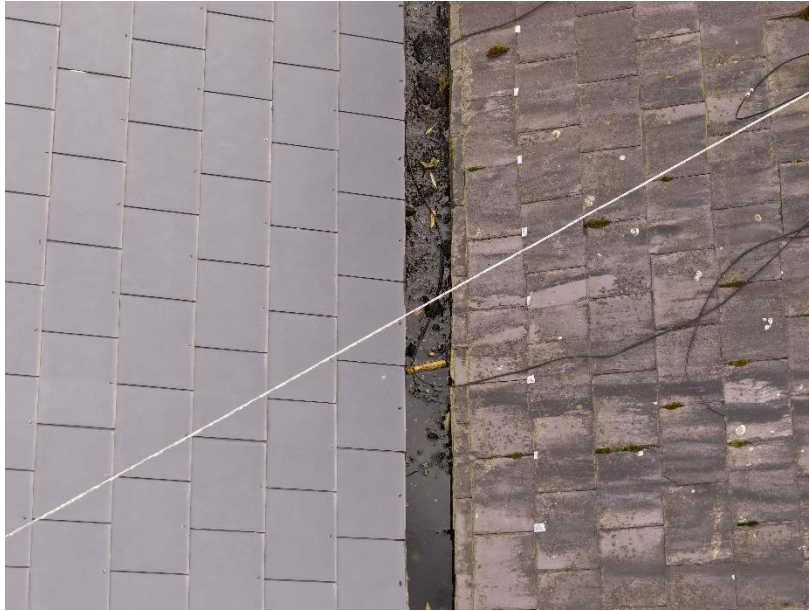
Debris in box gutter (72).

Clear debris from box gutter.

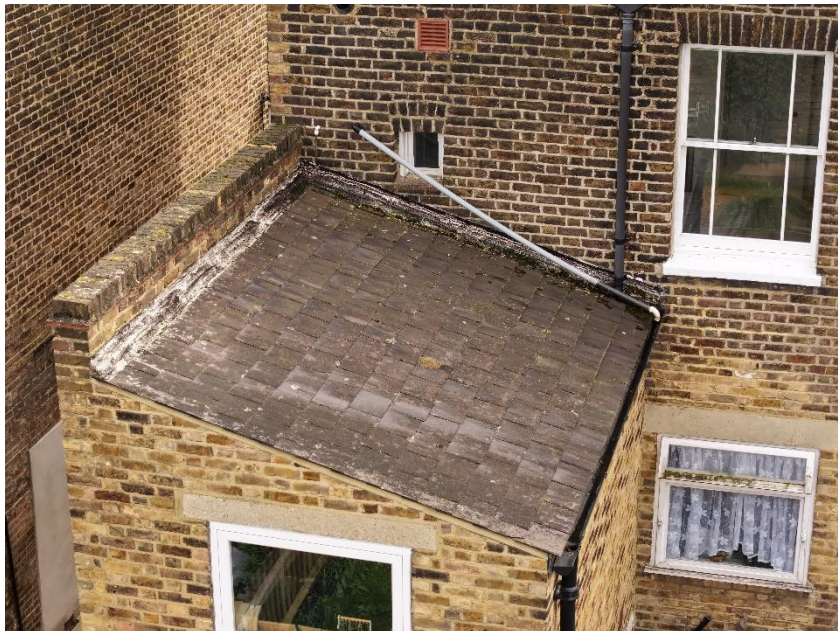
Rear addition roof fillets need replacing with lead. (15).

The lower rear addition roof needs attention. The pitch appears too low for slate, which could lead to water ingress during heavy rain and strong winds. The fillets are in poor condition and should be replaced with lead. Ideally, this roof section should be completely renewed.

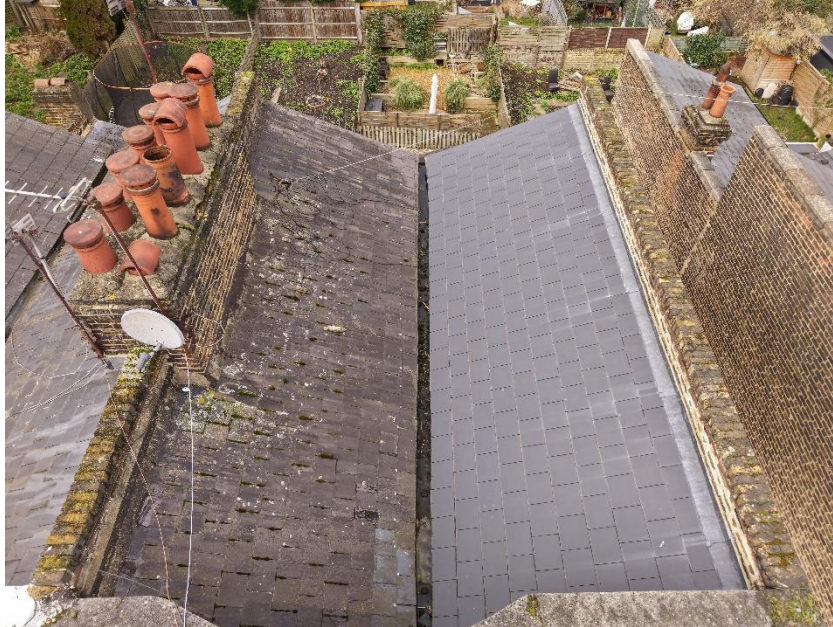
Right side new/ Left side original roof in bad condition. (32).

The left-hand slope appears to be original and should ideally be replaced. It would be advisable to use made slates to match with the right-hand slope. Additionally, the chimney requires re-flaunching, which involves re-capping around the chimney pots with sharp sand and cement. The chimney also needs re-pointing. The left-hand parapet wall also needs re-pointing or rendering, and the broken fillets should be replaced with lead.

Replace left hand slope and rear addition with new slates to match right hand slope.
