# Roof Condition Report (Level 2)

13 March 2025

4 Sample Road, SE8 \*\*\*

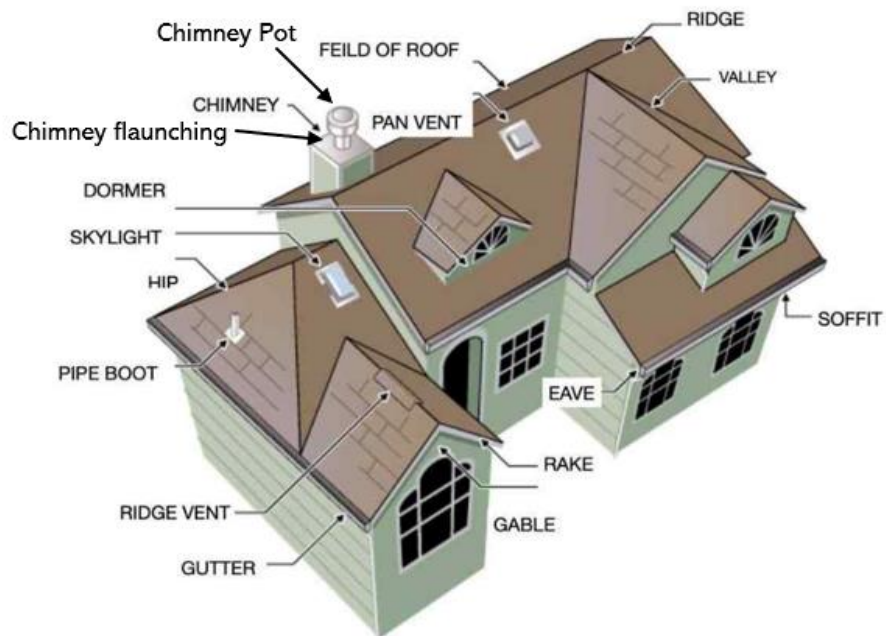
Diagram Reference:

The main roof features a double pitch design covered in slate, with a central box gutter. The right-hand slope has been recently replaced and appears to be in very good condition. Two minor issues have been identified:

1. The new lead flashing at the bottom is coming loose and requires re-fixing and the application of lead sealant.
2. The brick-on-edge atop the parapet wall needs cleaning and some repointing.

The left-hand slope appears to be original and should ideally be replaced. It would be advisable to use made slates to match with the right-hand slope. Additionally, the chimney requires re-flaunching, which involves re-capping around the chimney pots with sharp sand and cement. The chimney also needs re-pointing. The left-hand parapet wall also needs re-pointing or rendering, and the broken fillets should be replaced with lead.

The lower rear addition roof needs attention. The pitch appears too low for slate, which could lead to water ingress during heavy rain and strong winds. The fillets are in poor condition and should be replaced with lead. Ideally, this roof section should be completely renewed.

I would estimate to replace the left-hand pitch; lower rear addition roof and chimney works to cost £8,000-£10,000 including scaffolding.
